# Repair and Rehabilitation of Flexure-Failed RC Beam

**Index Terms**— RC beam, repair, rehabilitation, micro concrete.

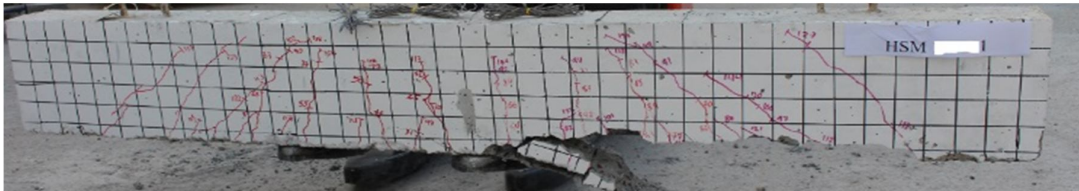
This paper elaborates the rehabilitation of a beam with dimensions 140 x 280 x 2000 mm that has failed due to flexural loading causing the loss of rebar cover. The details of two beams are discussed in this paper, which are, the control beam named CB; and the rehabilitated beam named REMB, before and after rehabilitation. The beam to be rehabilitated had been tested under four-point loading. Upon failure, the beam experienced concrete separation from the rebar cover level, exposing the tension reinforcements (Fig-1). The objective of this experiment is to rehabilitate this beam, which had failed due to flexure and rebar-cover

Figure 1- Beam REMB before Rehabilitation

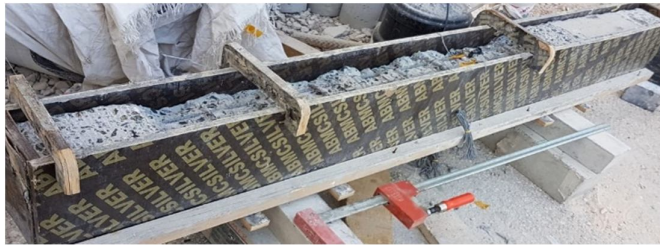
Figure 2-Form work for concreting

The primary step of the rehabilitation process is to remove loose concrete material from the tension side of the beam (Fig-2). The concrete is chiselled out until the concrete cover level, exposing at least 50% of the tension rebar steel. The remaining debris is cleaned using a water jet with high pressure. Secondly, the cracks on the surfaces of the beam are sealed with FOSROC NITO-MORTAR FC, which is a high strength trowel grade epoxy repair mortar. The epoxy and resin are mixed according to the design criteria mentioned by FOSROC and applied with pressure over the cracks to make sure that the material has penetrated the cracks to a significant level. The irregularities/loss of concrete on the lateral surfaces of the beam were also filled with the epoxy. The epoxy is left to dry for two days at an ambient temperature of 36°C. Thirdly, the beam is placed with tension side facing upwards, and a wooden formwork (Fig-3) is built around the beam to cast the new layer of concrete. The formwork for the beam would extend the clear cover of the beam to 40mm. Strain gauges are attached on the tension steel rebars at the midspan of the beam.

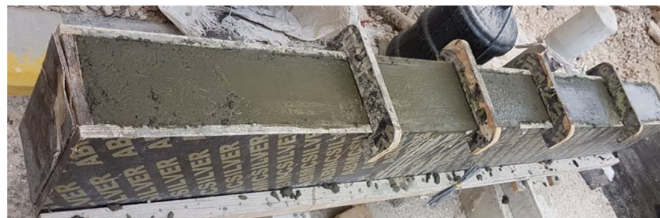
Figure 4-Post compaction of concrete

Prior to concreting, a coating of FOSROC NITO-BOND EP, an epoxy based concrete bonding agent is applied (Fig-4). This is to ensure the proper bond between the old concrete and the new concrete. Immediately after the application of NITO-BOND EP, FOSROC RENDEROC LA XTRA, a fluid micro-concrete is poured and compacted using hand compaction technique (Fig-5). After 24 Hours, the formwork is removed, and the new concrete is cured for 28 days.

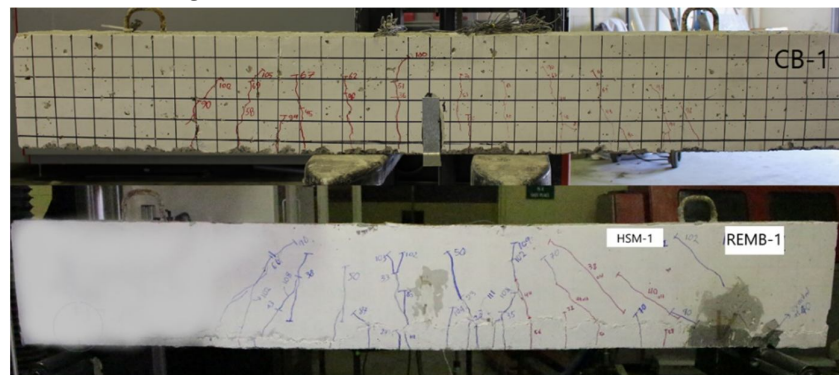
The cracks propagation (Fig-9) in the rehabilitated beam is similar to the beam CB. The cracks in the new micro-concrete were mostly continuation of the previous cracks in the old concrete. Although new cracks were formed, it was less in number. The continuity in propagation of cracks from the new concrete to the old concrete is an evidence to the excellent bonding between the old and the new concrete. The strain gauges attached at the interface of the bond between the new and old concrete exhibited a better understanding of the bond behaviour. The reading on the strain gauges indicate there is not much displacement between the old and new concrete.

Figure 9-Crack Propagation in CB and REMB
