## Details: Thermography Audit of Ring Spinning Machine in Cotton Industry

Dr. B. Y. Bagde<sup>1</sup>, P.B. Joshi<sup>2</sup>, Mr. P. S. Shete<sup>3</sup>, Mr. C. R. Bhale<sup>4</sup> and Prof. Vaishali Tendolkar<sup>5</sup>

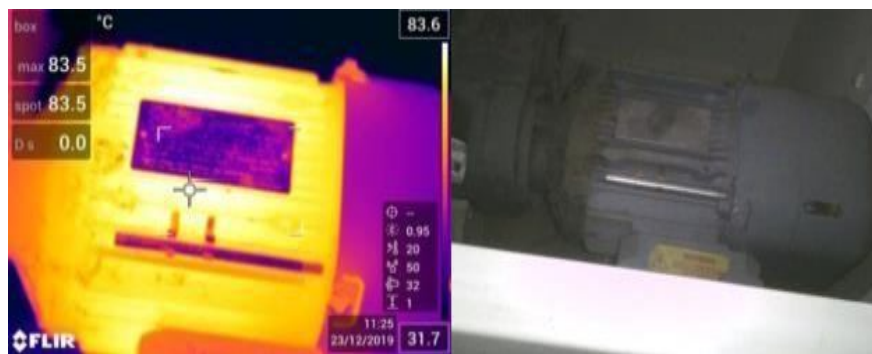
Figure 1. Belt motor found a heated condition at bale Plucker  
a) IR Image b) Visible Image

Remark: The conveyor drive belt motor at Bale Plucker was found heated and suggested checking the following things

- Motor winding condition and bearing condition 2. Lubrication schedule 3. Belt Alignment 4. Cleaning condition

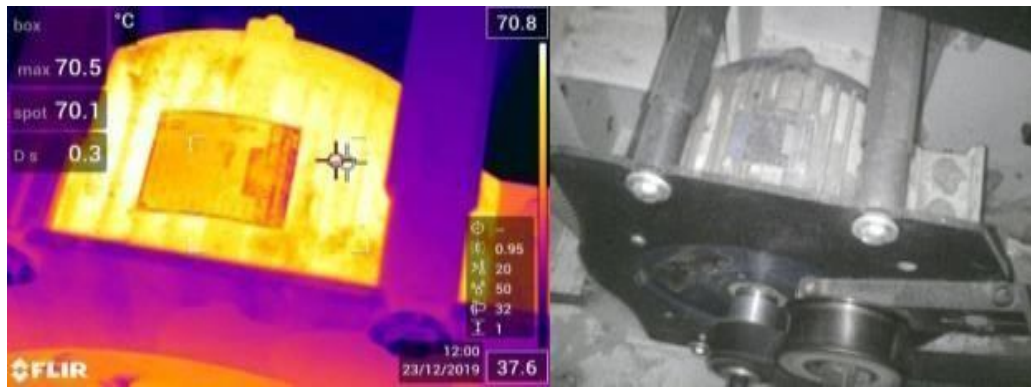
Figure 2. Doffer Motor Found Heated Condition At Card No-2  
a) IR Image b) Visible Image

Remark - 1. Motor winding condition and bearing condition 2. Lubrication schedule 3. Cleaning condition 4. Belt Tension

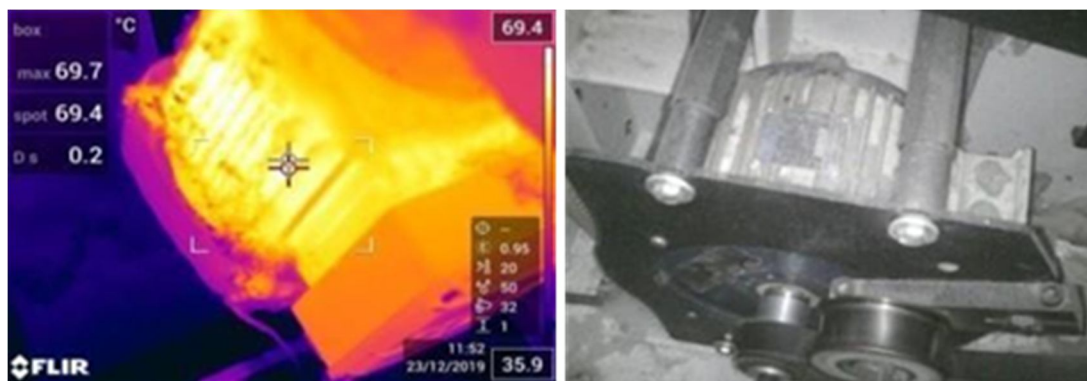
Figure 3. Doffer Motor Found Heated Condition At Card No-2  
a) IR Image b) Visible Image

Remark- Doffer motor at card no. 4 found in a heated condition. Suggested checking the following things.  
1. Motor winding condition 2. Lubrication schedule 3. Cleaning condition

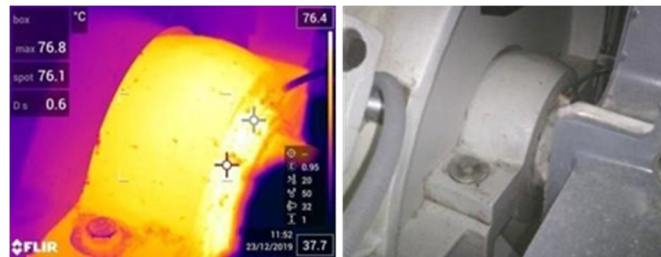
Figure 3.4. Cylinder bearing housing lhs at card no-1 found heated condition  
a) IR Image b) Visible Image

Remark- Cylinder bearing housing LHS at card no. 1 found in heated condition. Suggested to check the following things Lubrication schedule 2. Cleaning condition 3. Check bearing condition

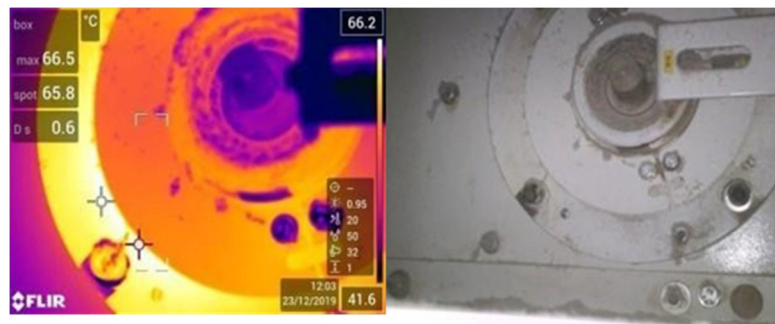
Figure 5. opening roller bearing housing at card no-3  
a) IR Image b) Visible Image

Remark- Opening roller bearing housing LHS side card no. 3 found a heated condition. Suggested to check the following things

1. Check side frame jamming
2. Lubrication schedule
3. Cleaning condition
4. Check bearing condition

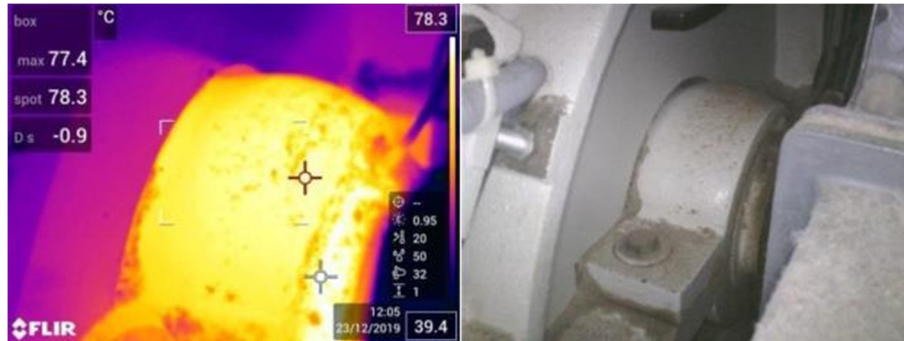
Figure 6. Cylinder bearing housing at card no-3 found heated condition  
a) IR Image b) Visible Image

Remark- Cylinder bearing housing LHS at card no 03 found heated condition. Suggested to check the following things

1. Lubrication schedule
2. Cleaning condition
3. Check bearing condition.

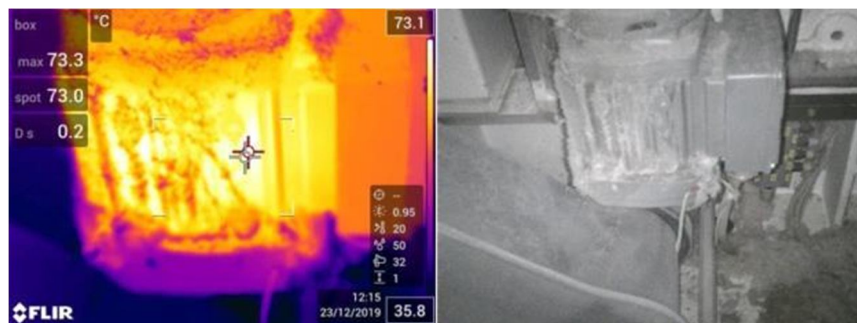
Figure 7. Card feed motor at card no found heated condition  
a) IR Image b) Visible Image

Remark- Suggested check the following things 1. Bearing condition and motor winding condition. 2. Motor servicing schedule 3. Lubrication schedule 4. Cleaning Schedule
