# Vulnerability Assessment of All Saints' Church - a Unique Heritage Building in Bengaluru

**Index Terms**— vulnerability assessment, heritage building, unreinforced masonry, dynamic analysis.

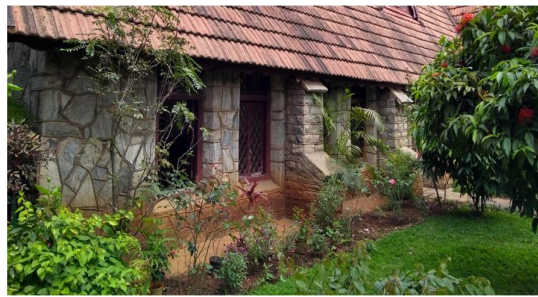
3. Buttresses: The steep roof held by the trusses exerts a high lateral push, which is counteracted by the buttresses provided all along the building. A total of four pairs of buttresses are provided for each of the trusses on both sides of the nave. Two pairs are provided on the far corner of the transept and two on the apse. The buttresses are composed of coursed stone masonry in lime mortar. The joints are covered with cement pointing. The buttresses in the nave are 2.18m in height and those in the transept and apse are 4.26m.

Figure 2. Buttresses in Nave

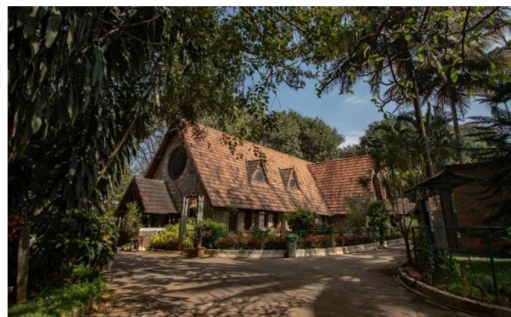
4. Roofing System and trusses: A Gothic-style crossed-gable/crossed-A frame roof has been adapted in All Saints' Church. The transept portion consists of two gables and a Madras Terrace. Two layers of Mangalore tile cover the roof. The roof starts from the nave wall at a mere height of 3.47m. It makes an angle of  $53^\circ$  to the horizontal. The inner height from the bottom surface to the ridge beam is 8.20m. Four purlins on both sides run along the length of the nave. Two dormer windows are present on either side of the nave roof. The two gables in the transept resemble the letter 'M'. The angle of the roof is  $65^\circ$  to the surface and the height of the ridge beam is 7.55m.

Figure 3. All Saints' Church

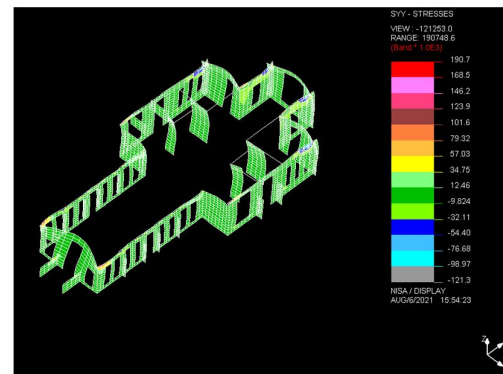
Figure 9. Stress Contour ( $S_{yy}$ ) due to acceleration in y-direction

The maximum flexural stresses in the vulnerable regions as obtained from the stress analysis performed by applying a uniform lateral acceleration of 0.2g is presented in Table III. It can be seen that the maximum extreme fiber stress developed is 0.121MPa. This is limited to a small region at the corners and junctions. The masonry is capable of withstanding this level of stress. It was noted that the shear stresses were marginal, expectedly, due to the adequate shear resistance by way of wall thickness and the presence of a large footprint of shear walls in both directions.
