# A Critical Review of Road Failures due to Major Earthquakes in Asian Continent

**Keywords:** Asian continent, Earthquakes, Road failure, Failure pattern, Design methodology.

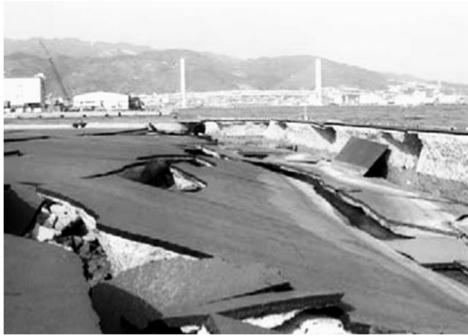
Figure 1. Road damage due to Great Hanshin/Kobe earthquake [3]

Complete collapse of road structure due to the Kobe earthquake that occurred on January 17, 1995, is shown in Fig. 1. The reported moment magnitude is 6.9, MMI scale value is X and RDS is 5. This figure shows the complete collapse of road

structure, where the road segment is completely malfunctioned requiring to repair thoroughly or re-construct. Possibly, due to formation of large tensile stresses in the surface layer because of strong ground motion, the surface course of flexible pavement is severely divided into big plates, where some plates settled down of few feet because of the brittle behavior of the underlying layers. It has been reported that various areas has suffered subsidence due to strong ground motions and severe liquefaction of the soil [3]. Ground surface rupture due to Bhuj (Gujrat) earthquake January 26, 2001, is shown in Fig.2. The reported moment magnitude is 7.7, MMI scale value is X and RDS is 5 [4]. Longitudinal cracks in the crest of the embankment were observed in some locations of the affected area due to inelastic deformation and these ground splitting at several places were developed as a part of slope failure. Cracks were also seen in some asphalt roads at few locations, indicating the possibility of failure due to ground slippage and landslides [5,6]. The damage of road due to October 8, 2005 Muzaffarabad earthquake is shown in Fig. 3. The reported moment magnitude is 7.6, MMI scale value is X and RDS is 4. The flexible pavement surface was cracked transversely in that particular location and ripped a fault line in the surface layer possibly due to the presence of soft soil or weaker underlying layers. However, it can be assessed that due to ground shaking large amount of tensile stress was developed which tends to create a fault line in this road section. [7]. The damaged and blocked road due to Wenchuan, China earthquake on May 12, 2008, is given in Fig. 4. The reported moment magnitude is 7.9, MMI scale value is IX and RDS is 4 [9]. This figure shows that trucks were smashed and trapped by rolling boulders due to the effect of landslides affecting traffic movement. In this image, the road structure is not severely affected, but resulted in partial or complete blockage to short sections of road. Such landslides mostly occurs as shallow and localized slope failures in roadside cuttings, though below-road slope failures are also common. Even some damage of roads were also observed in the city, where the road was un-passable for vehicles [10]. Damaged road in Tarlay, Shan due to Myanmar earthquake on March 24, 2011 is shown in Fig. 5. The reported moment magnitude is 6.8, MMI scale value is X and RDS is 5 [11]. This figure shows damaged road having deep longitudinal crack pattern with vertical displacement in the affected area. Vertical displacement of 1.5 metres in subsidence was observed in the area [12]. Perhaps, such failure were observed due to fatigue failure or shrinkage and as well as due to hardening of flexible pavement layers. Damages were also reported in Tachileik, Nyaung, and Monglin, but limited details about the road damages are available.

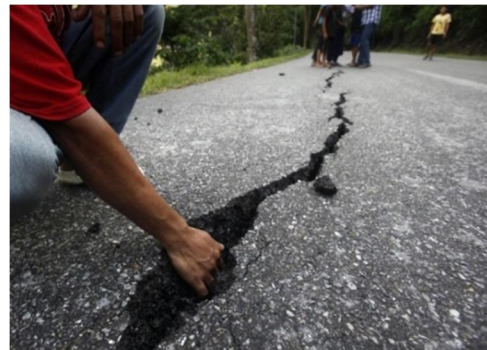
Figure 6. Road damage due to Sikkim earthquake [15]

A section of road splitted due to Sikkim earthquake September 18, 2011, is shown in Fig. 6. The reported moment magnitude is 6.9, MMI scale value is VII and RDS is 3. This figure shows that the wearing course of flexible pavement surface was ruptured longitudinally in that particular location probably due lack of mix stiffness and ductile behavior, which were unable to sustain the tensile stress generated during earthquakes. However, in some sections transverse cracks also occurred on the pavement surface and extended the entire width of the pavement [14]. Fig. 7 shows the tear down of road due to Nepal earthquake on April 25, 2015 . The reported moment magnitude is 7.8, MMI scale value is IX and RDS is 5. This figure shows the settlement of the pavement after transversely cracked. Perhaps such type of failure happens due to weaker subgrade; as due to ground vibration the shear strength of the subgrade soil mass and stiffness of the base layers gets

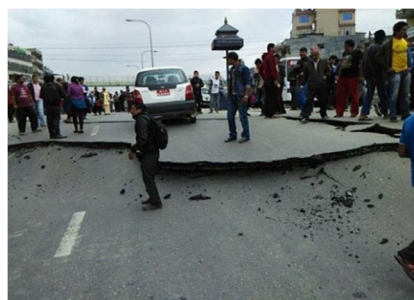
Figure 7. Road damage due to Nepal earthquake [17]

destabilized, which creates large amount of underlying layers to shift position. Primarily the earthquake triggered an avalanche on Mount Everest, and hence landslides occurred in the Trishuli River Valley also [16]. Such roads require complete reconstruction for effective traffic movement.
